Appendix 1: Geomorphology Assessment

TECHNICAL MEMORANDUM

Re: Task 4: Poesten Kill Watershed and Flood Mitigation Assessment: Geomorphic Assessment and Review of Potential Flood Management Options

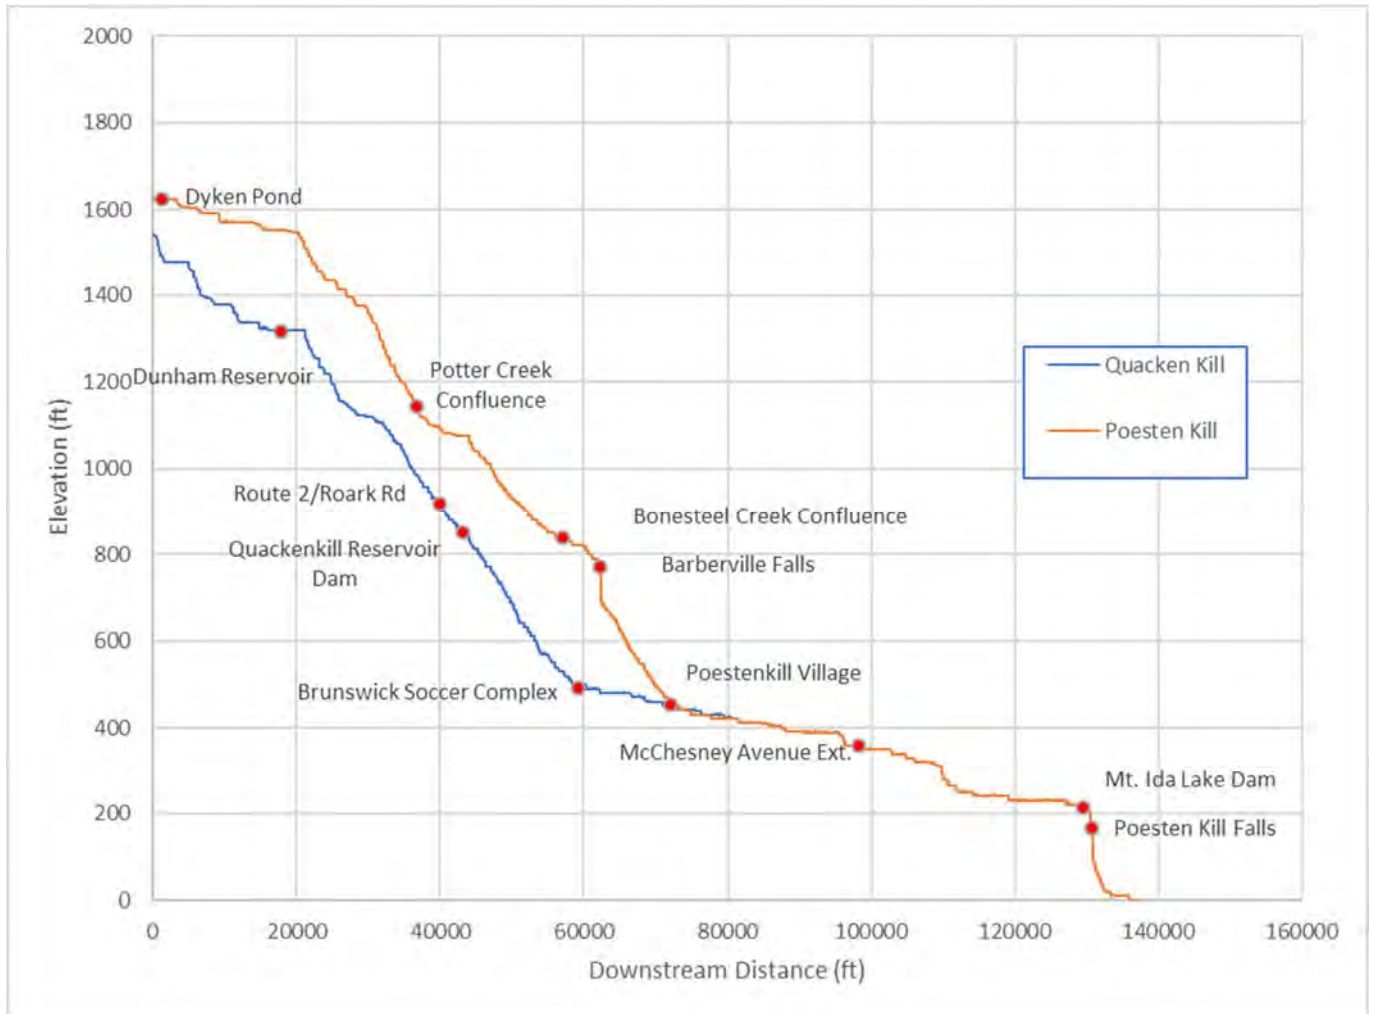
Figure 2. Longitudinal profiles of the Poesten Kill and Quacken Kill, from the headwaters to the confluence with the Hudson River. Points of interest referenced in the report are shown along the profile as red dots. Elevation data derived from 10-meter DEM (CUGIR).

The landscape of the Poesten Kill watershed is dominated by a prominent topographic step defined by the western boundary of the Rensselaer Plateau (Figure 2). This topographic control accounts for many of the patterns of flood and sediment transport dynamics observed in the watershed. The upper reaches of the Poesten Kill and Quacken Kill that originate on the plateau and flow west down the escarpment, are characterized by steep and confined channels with small floodplains. Slopes along the mainstem channels are on the order of 100 ft/mile or 0.02 (Table 1), with higher slopes occurring locally and along tributaries. The combination of high slope and confinement is capable of generating flood flows with sufficient velocity and depth to erode and transport the abundant sediment present in the surficial deposits forming the hillslopes adjacent to the channels as well as other debris (e.g., large wood). This is reflected in anecdotal descriptions of the damages experienced during Tropical Storm Irene which included loss of riparian trees, blocking of culverts, and catastrophic failure of associated road infrastructure such as the damage to Route 2 near the intersection with Stuffle Street in Grafton (Quacken Kill), Plank Road in Poestenkill (Poesten Kill), and Fifty Six Road in Poestenkill (Potter Creek).

These steep upland reaches transition abruptly onto the broad plain at the base of the plateau, and channel slopes reduce dramatically (Figure 2 and Table 1). When flows reach this break in slope, they slow and expand onto the floodplain, resulting in a rapid reduction in sediment transport capacity and abrupt deposition of sediment. During Tropical Storm Irene, deposition of substantial volumes of sediment along the Quacken Kill in the Towns of Brunswick and the Poesten Kill in the Town of Poestenkill damaged soccer fields and residential property and filled the channels, reducing conveyance capacity and forcing more flow overbank.

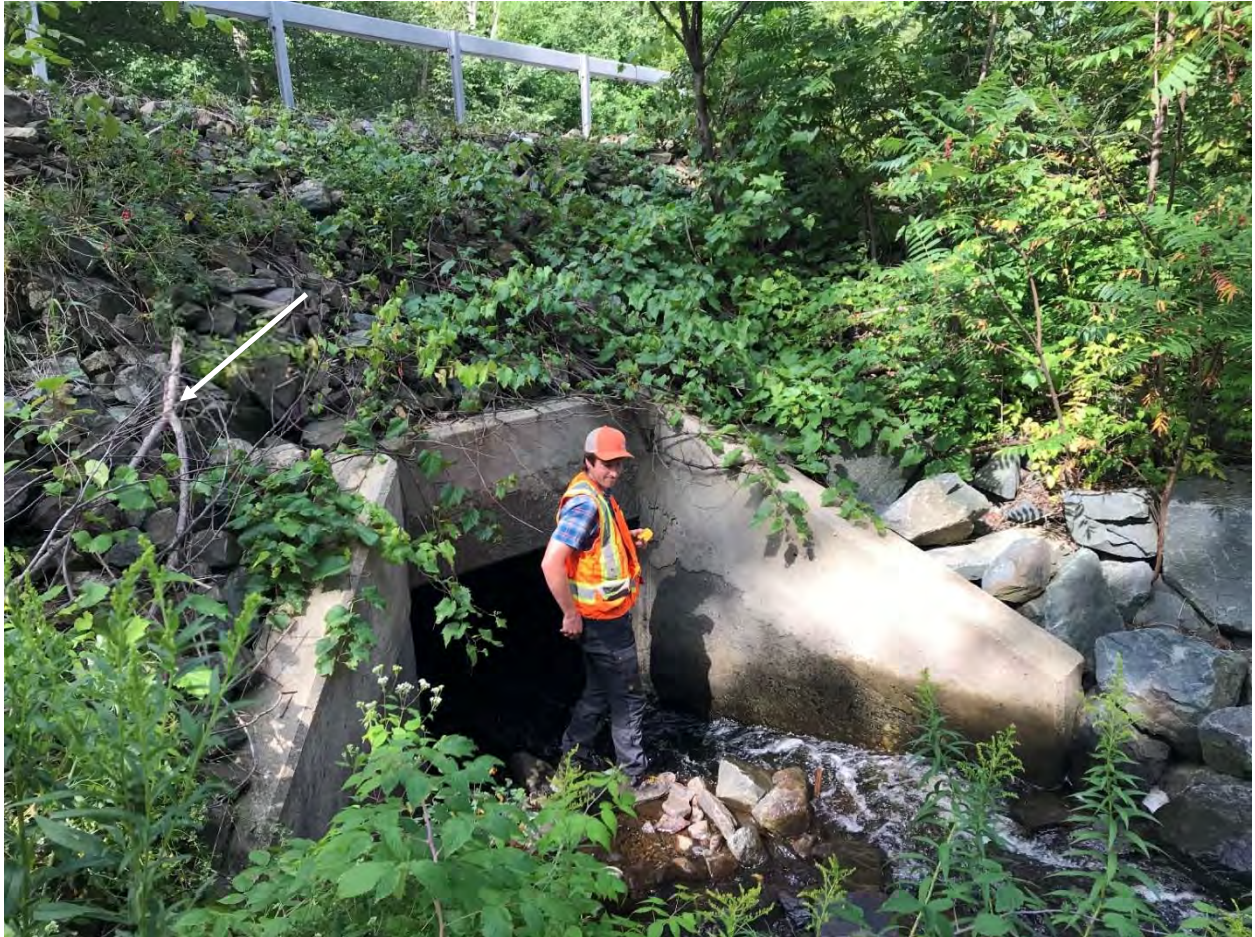
A tributary of the Quacken Kill crosses under New York State Route 2 near the intersection with Stuffle Street in Grafton. The drainage area at this point is 2.3 square miles. This site is located on the steep escarpment of the Rensselaer Plateau. The tributary is steep and confined as it approaches Route 2 where it flows into a 4.5-foot wide, 4-foot high concrete box culvert (Figure 5). The stream approaches the culvert at an angle, resulting in a situation that is hydraulically inefficient with the potential for scour by impinging flow against the right bank. A residence on Stuffle Street is located within 10 to 20 feet of the top of the right bank. The culvert, wingwalls, channel banks, and Route 2 road embankment show signs of relatively recent repairs. Anecdotal information and a subsequent conversation with the Town of Brunswick⁸ confirm that high flows during Tropical Storm Irene overtopped the culvert and washed out Route 2 at this location, interrupting access and causing substantial damage to the highway. It appears that the original culvert was repaired when the highway was rebuilt but was not replaced with a larger structure with a more hydraulically favorable orientation. Woody debris was observed on the road embankment slope above the headwall, indicating that more recent high flow events than Irene have caused water to back up behind the culvert.

Figure 5. Tributary culvert entrance beneath Route 2 near intersection with Stuffie Street in Grafton. Note concrete repairs to wingwalls and headwall and rip rap repair to right bank. White arrow indicates debris most likely deposited during a recent high flow event when flow backed up behind the culvert.

Location of example project	Description	Figure in Appendix B
Route 2/ Roark Road (escarpment)	Replace the Route 2 and Roark Road tributary crossings with structures sized to the channel and adequate to pass extreme floods, including debris generated during extreme floods. Remove relic culvert at disused crossing between Route 2 and Roark Road. Project would reduce the risk of flood damages, improve local resilience to flooding, and reduce risk of public safety.	
Quacken Kill Reservoir Dam (escarpment)	Confirm structural integrity of dam and investigate feasibility of removal to eliminate maintenance and the risk of failure and to restore the channel and aquatic organism passage. Alternatively, maintain a robust inspection schedule and make repairs as necessary to ensure the integrity of the structure.	
Quacken Kill along Route 2 (escarpment)	Evaluate low-lying stretches of Route 2 for flooding issues and raise the road if necessary to reduce risk and eliminate need for dredging. Install valley-spanning engineered large wood structures where opportunities exist to increase floodplain storage, slow flows, control grade in the channel, and trap coarse sediment. Implement bioengineered bank erosion control projects where appropriate to stabilize coarse sediment.

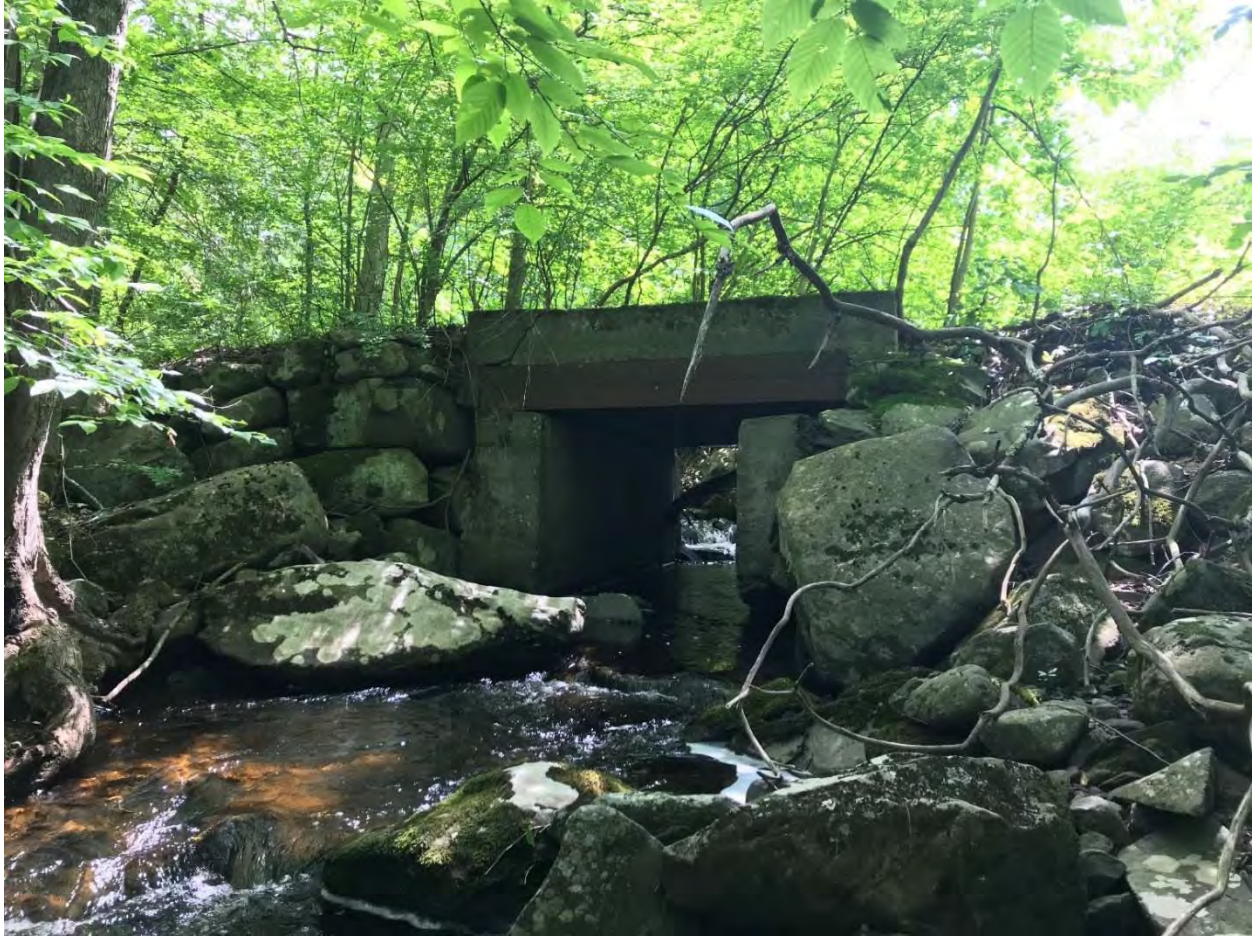
Figure 6. Looking upstream at relic culvert from a disused road crossing of the Quacken Kill tributary between Route 2 and Roark Road

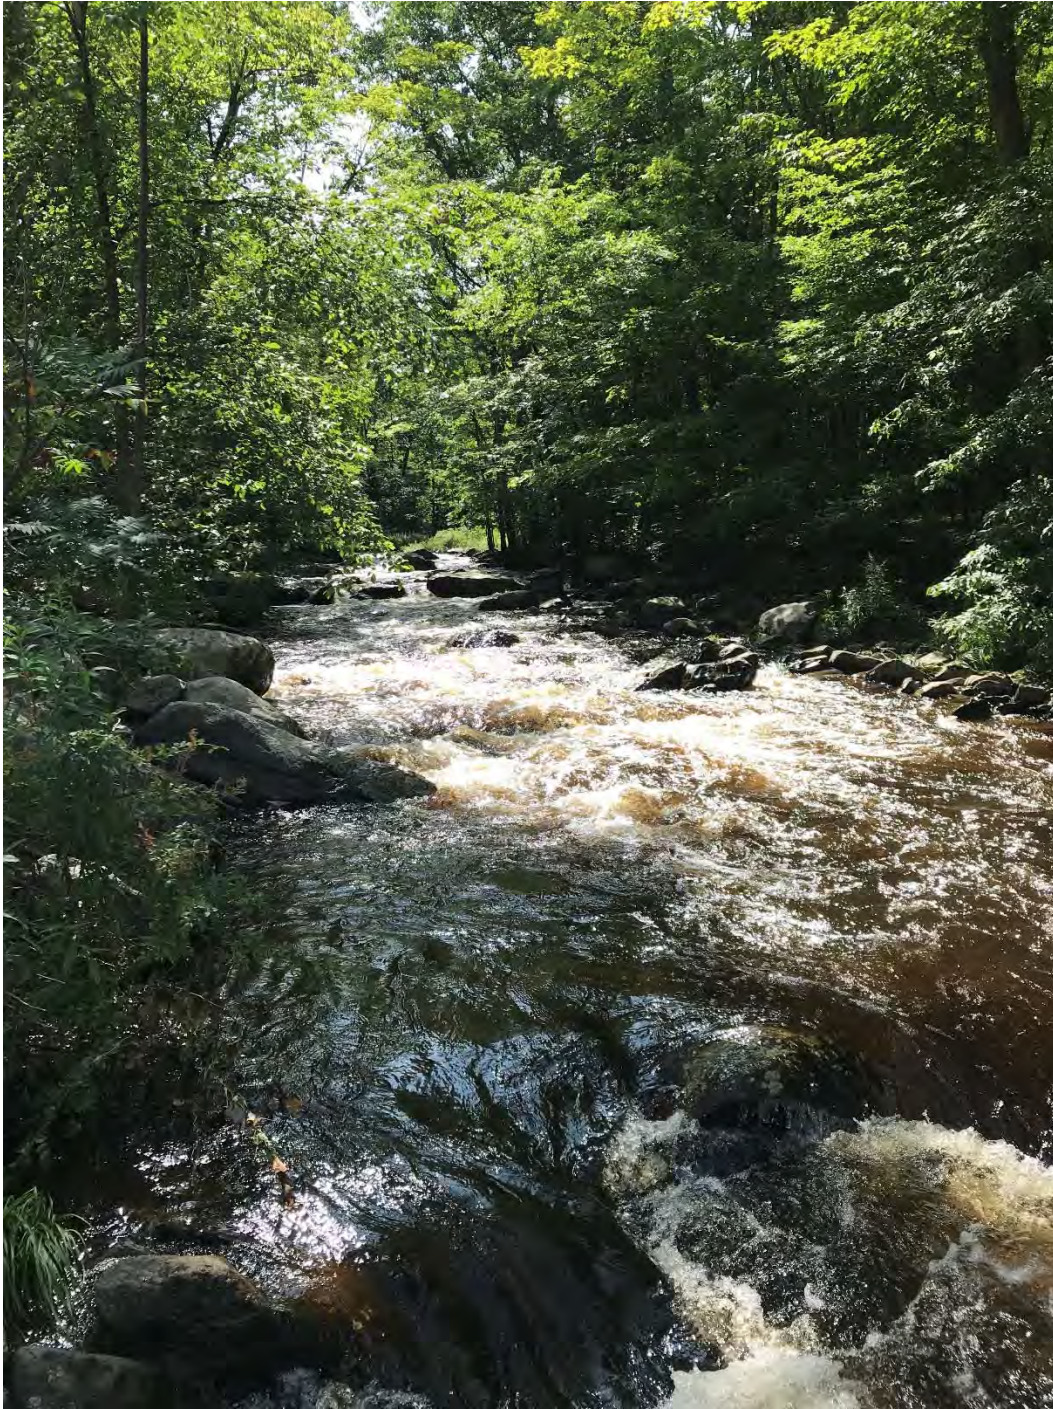
Figure 7. Quacken Kill immediately upstream of the Route 2 bridge at Paltisch Road and downstream of the Stuffle Street tributary confluence

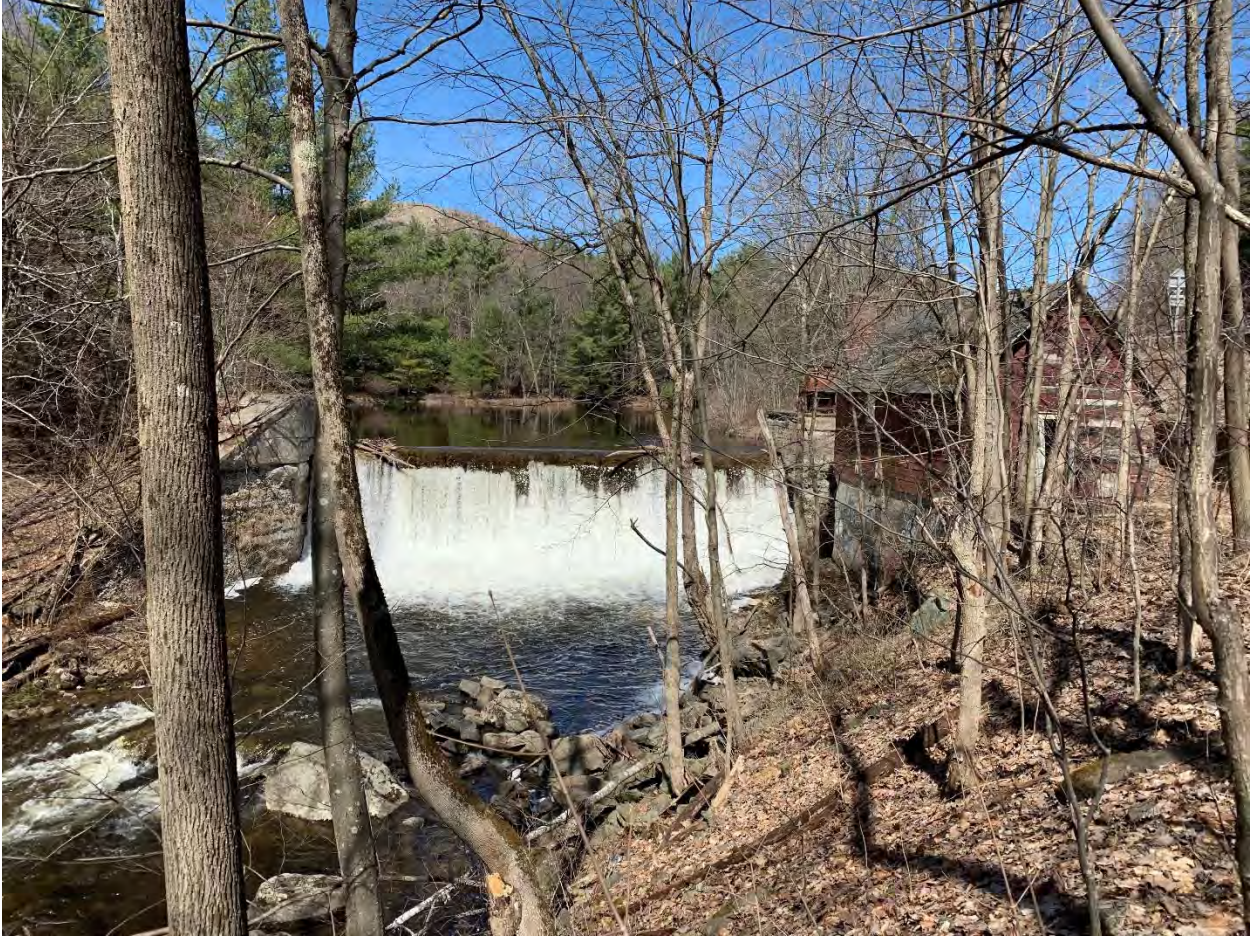
Figure 8. Quacken Kill Reservoir Dam

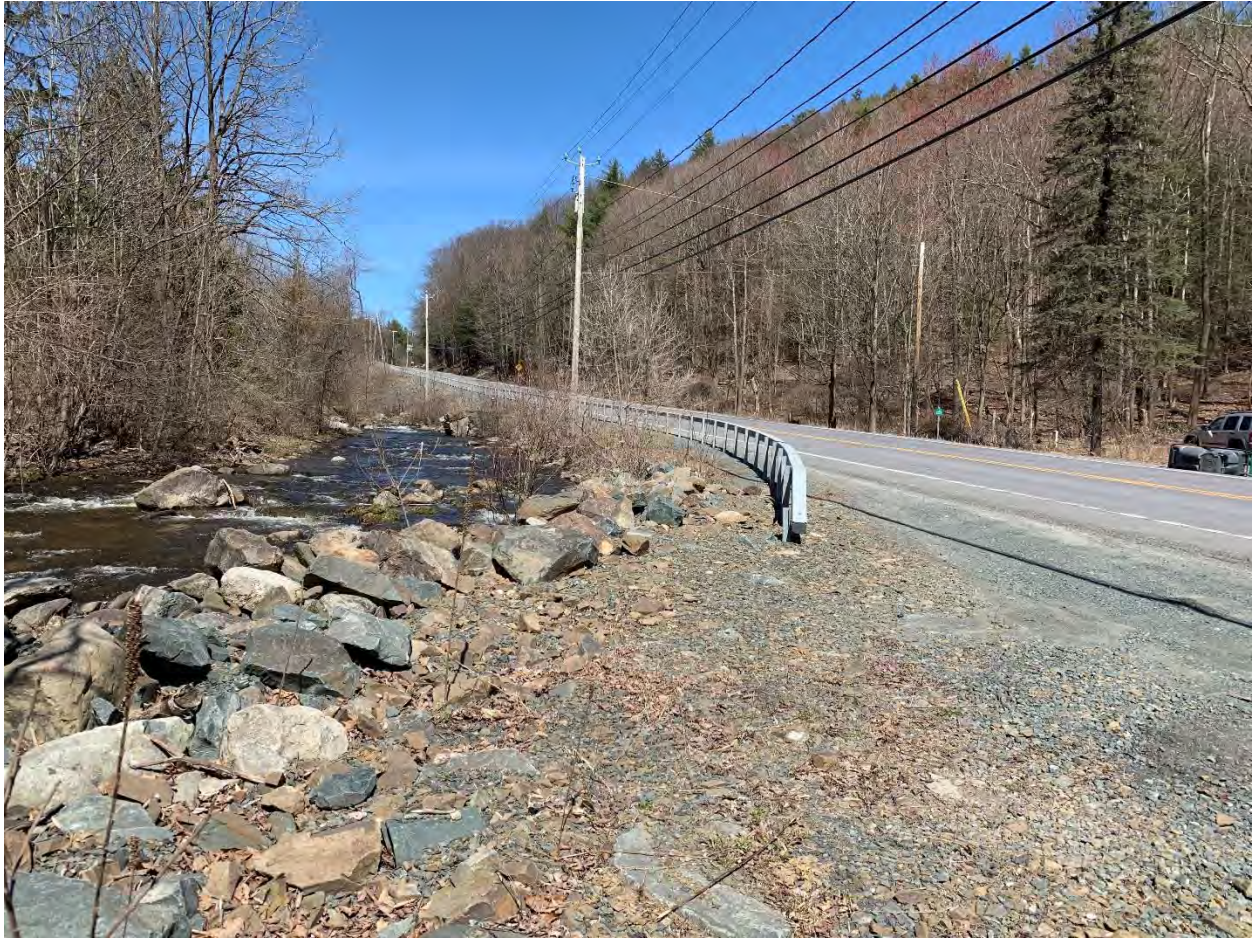
At two locations, the road surface dips down and sits nearly level with the top of bank (Figure 9). These locations appear to have been dredged and may be particularly vulnerable to flooding and damage. Where residential properties along Route 2 abut the stream, debris including construction materials and trash was found in the channel and along the banks.

Figure 9. Looking upstream along the Quacken Kill as it runs along Route 2

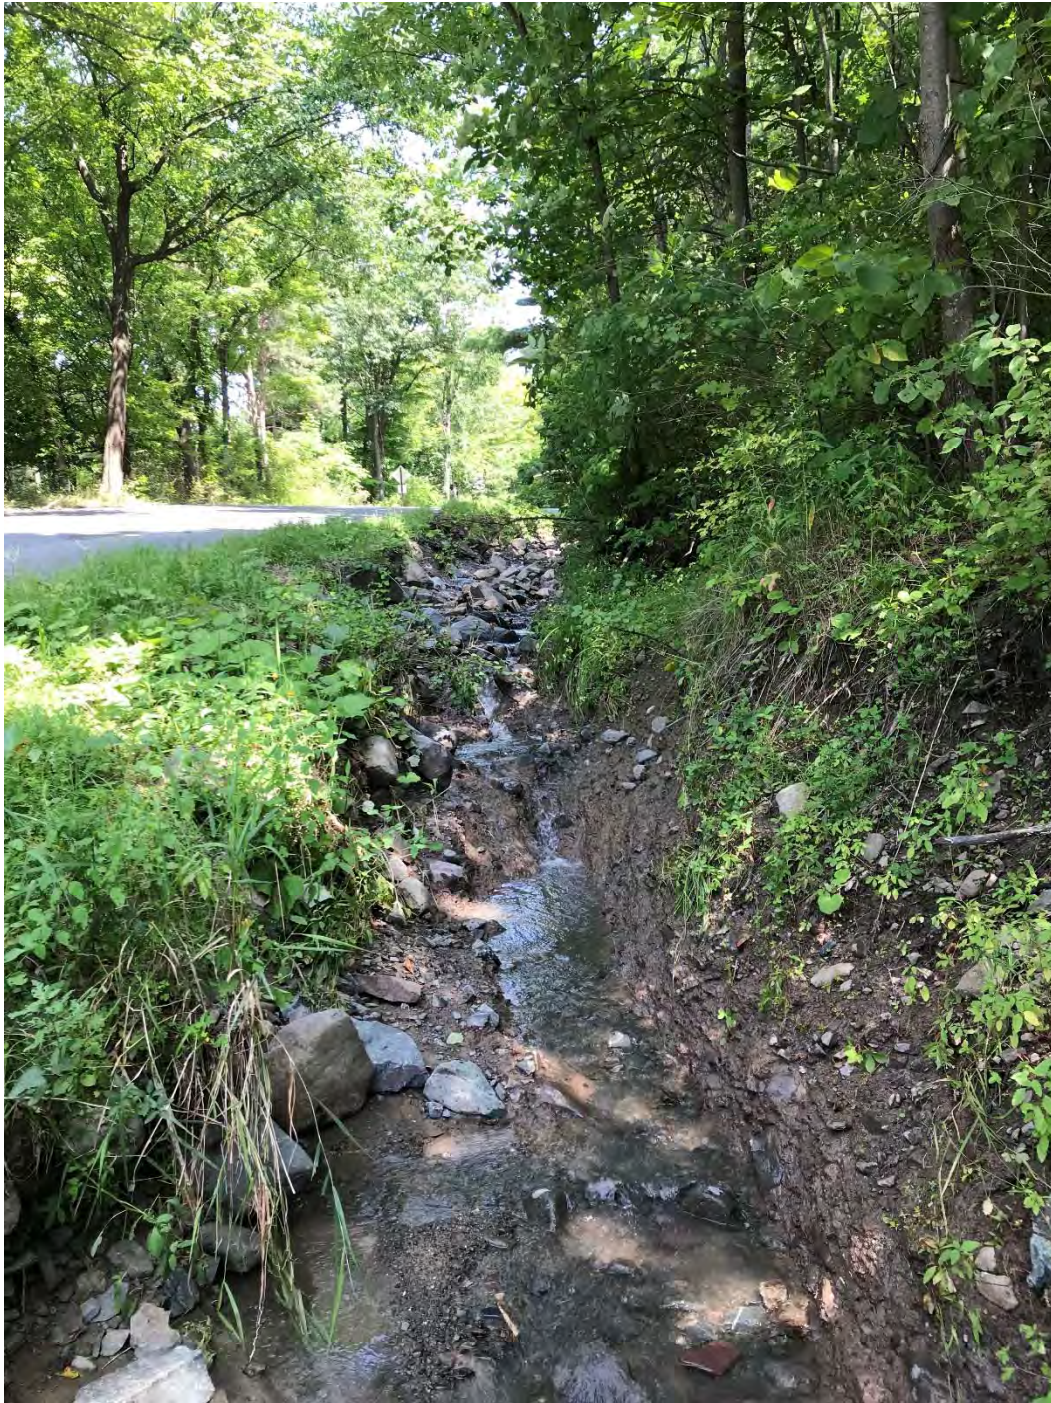
Rensselaer County¹¹ raised the issue of repeated washout and repairs of an incised drainage ditch running along South Road in Brunswick (Figure 10). This site is located near the bottom of the escarpment, just upstream of Brunswick Soccer Complex. The road and ditch, which have been cut into a steep hillside, intercept overland flow paths, small intermittent hillside drainages, and shallow subsurface stormflow (i.e. shallow groundwater moving through soil) that would have otherwise discharged to a low-lying wetland area at the bottom of the hillside as shown in Figure 11. The wetland is not currently shown in mapping by USFWS or NYS DEC. The wetland would naturally drain to the south, and its current outflow is via a 1-foot-diameter culvert under a low spot on South Road. During the survey, there was evidence that the recent rain storm had washed gravel and cobbles out of the ditch and across the road at the bottom of the hill. The material cleaned off the road and out of the ditch at the base of the slope has been piled up along the sides of the ditch to

form berms. Another berm has been constructed near the outlet of the wetland to prevent water backing up behind the culvert from overtopping the road.

Figure 10. Incised ditch along South Road, Brunswick

South Road (escarpment)	Install regularly spaced ditch relief culverts to intercept road drainage and route flows into an existing wetland. Regrade and repair the road ditch. Replace the culvert under South Road at the outlet to the wetland with an appropriately sized structure and construct a berm to prevent overflow from the wetland onto the road. Consider raising the road over approximately 300 feet at the crossing to prevent overtopping. Confirm adequate sizing of downstream culverts. The project would reduce flood damages, increase the resilience of the road, and slow runoff.	Concept 1

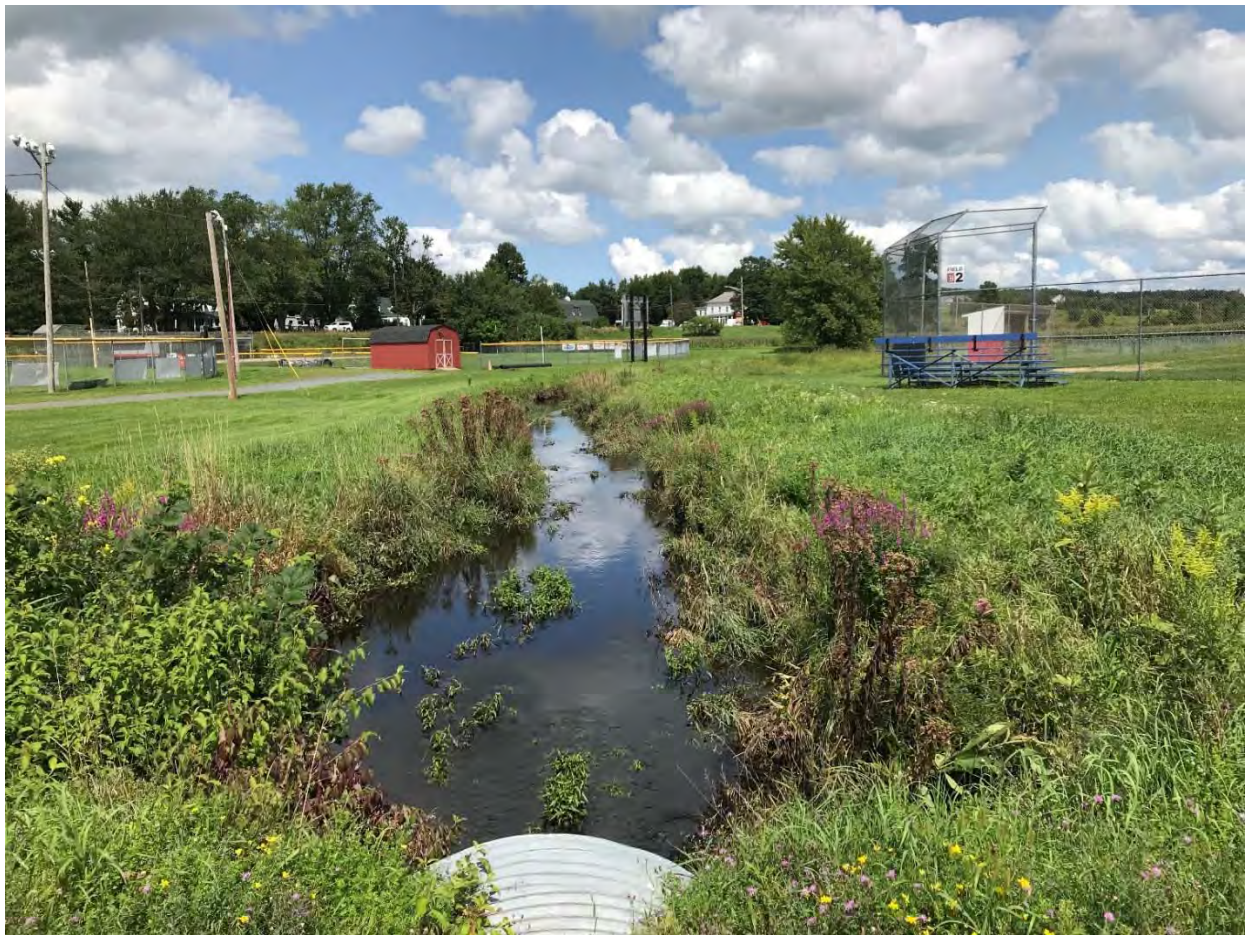
A tributary of the Quacken Kill flows through a wetland draining a low-lying area at the toe of the escarpment between the Tamarac Middle and High School and Tamarac Road in Brunswick (Figure 12). The drainage area at this point is 3.6 square miles. At the outlet of this wetland, the flow enters an earthen canal that conveys the water along a farm field and through the Brunswick Sports Complex. In total, the canal runs nearly a mile to the confluence with the Quacken Kill. The canal is trapezoidal and measures approximately 22 feet wide and has been dredged to a depth of approximately 5 to 6 feet below the surrounding floodplain surface (Figure 13). The bed is muddy and weedy with no bedforms present. Flow on the day of the survey was approximately 1.7 feet deep and sluggish despite observations of moderate flow and flow velocities in other channels on the day of the survey.

Figure 13. At the Brunswick Sports Complex on Route 2, looking upstream at the tributary draining wetlands along Tamarac Road

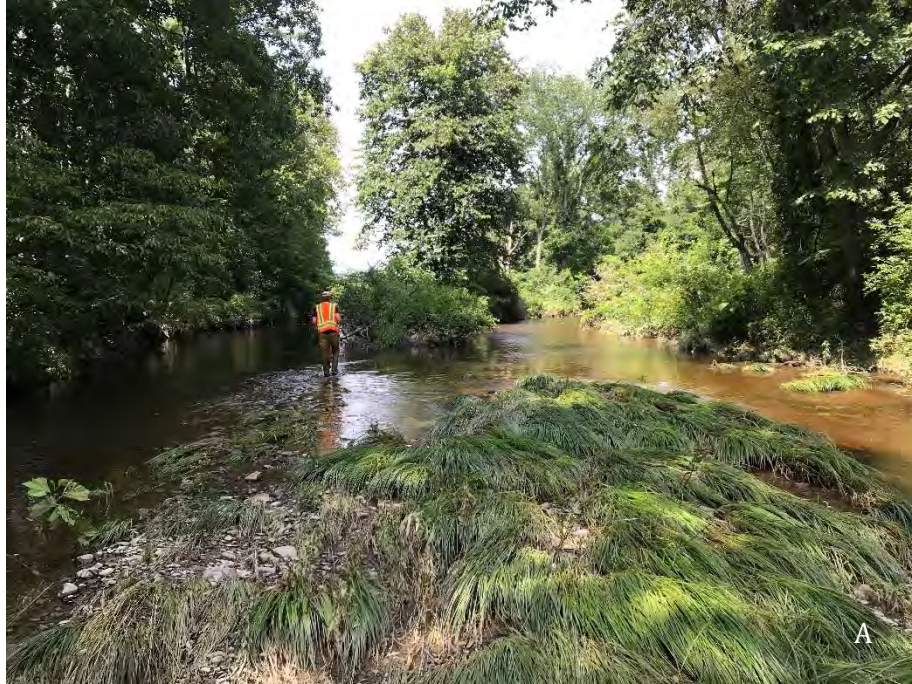
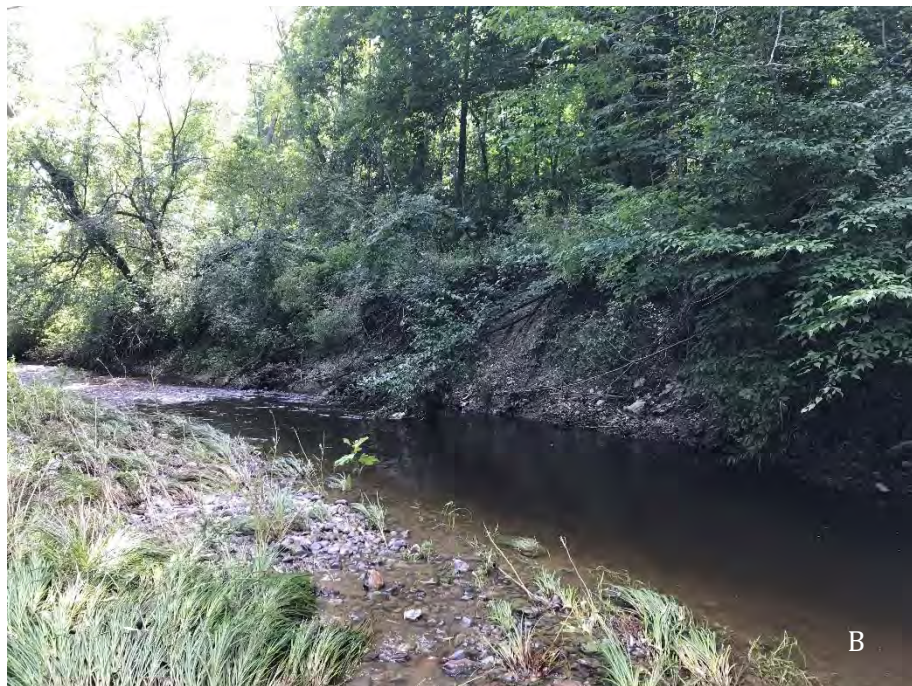
A large mid-channel bar has formed at the confluence where the drainage canal empties into the Quacken Kill (Figure 14). The cross section at this location is locally relatively wide, which causes flood flows from the Quacken Kill to slow and deposit bed material, building the bar. Evidence of recent flattening of the vegetation growing on the bar indicates that although flow in the Quacken Kill was still moderate at the time of the survey, it had receded since the peak of the runoff following the 2-inch precipitation event. As discussed in the previous section, moderate flow in the Quacken Kill appeared to be causing a backwater effect in the upstream drainage canals (Figure 14B). Surface flow velocity in the Quacken Kill was estimated in the field to be approximately 4 ft/s; surface flow velocity along the drainage canal was negligible.

Figure 14. (A) Looking downstream across the mid-channel bar at the confluence of the drainage canal on right and mainstem Quacken Kill on left. (B) Drainage canal where it enters Quacken Kill showing backwater effect as a result of moderate flow level in the Quacken Kill.

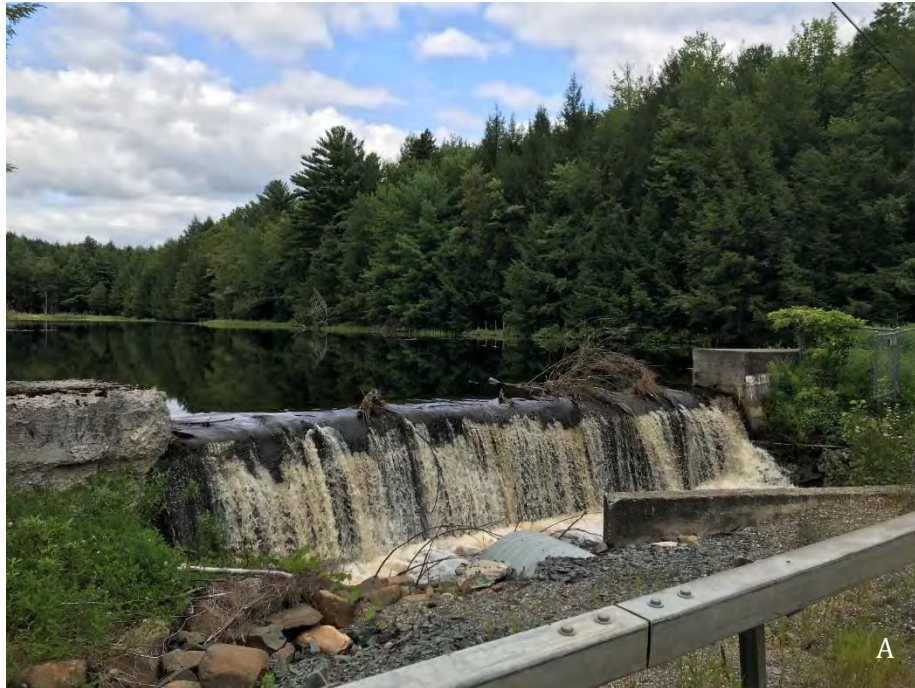
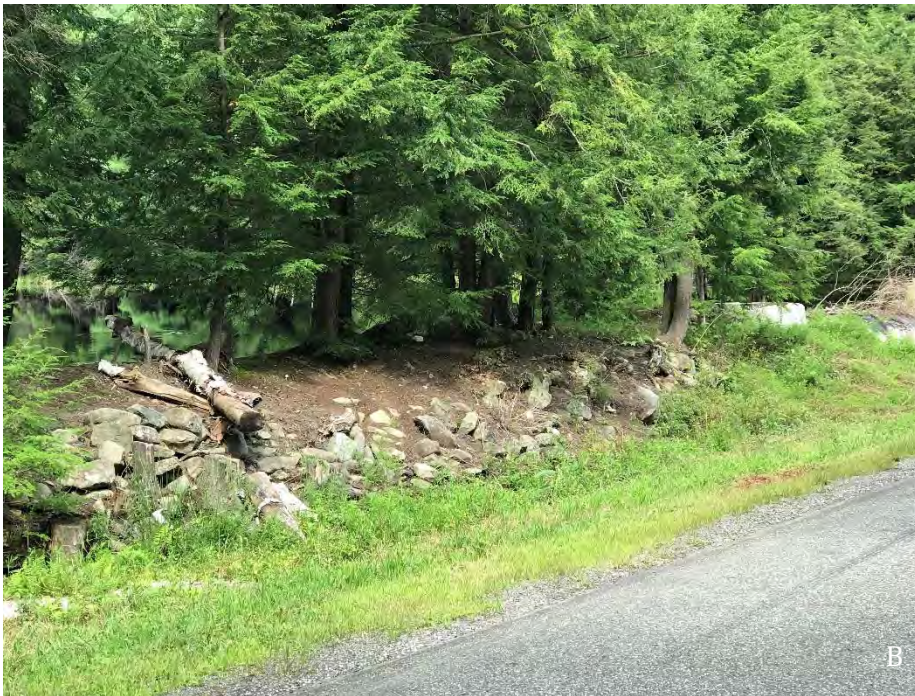
Improvements were also made to the earthen embankment portion of the dam on river left following Tropical Storm Irene. The embankment on river right exhibits bare soil, extensive tree growth, and animal burrowing, suggesting that it may remain vulnerable to damage during future extreme events (Figure 15B).

Figure 15. (A) Campfire Girls Dam taken from North Road. The culverts carrying flow from the base of the spillway under the road are visible in the foreground. (B) View of a portion of the earthen embankment on river right.

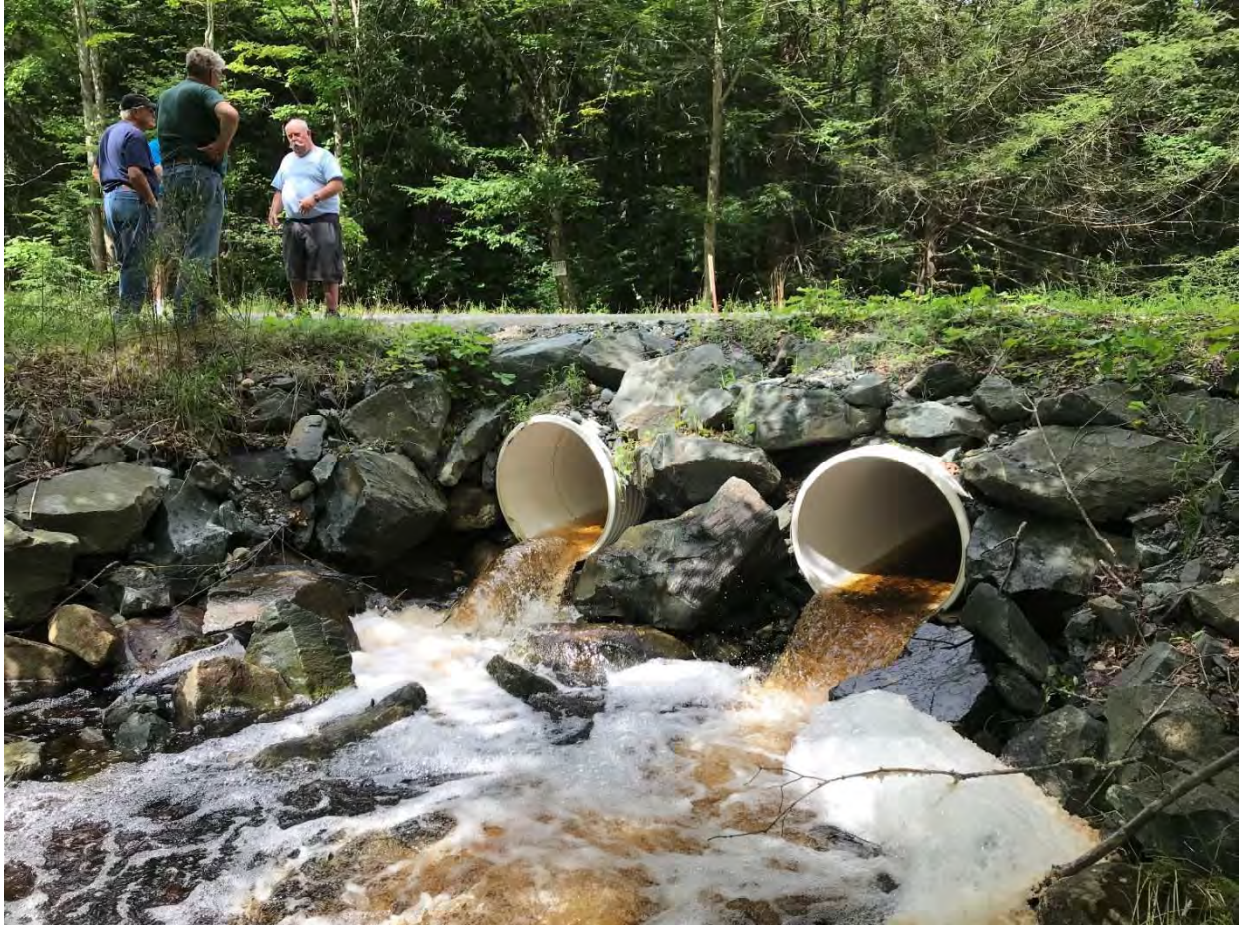
Approximately one mile upstream of the Campfire Girls Dam, Potter Creek flows under Fifty Six Road through twin 36-inch PVC culverts (Figure 16). The creek overtopped the road at this location during Tropical Storm Irene and destroyed a section of the road. The current configuration of the twin culverts plus an additional overflow culvert on the right bank was reconstructed by the Town of Poestenkill as a like-for-like replacement of what was in place prior to Irene. High-water marks from the recent precipitation event indicated that the culverts had been flowing more than half full.

Figure 16. Outlets of twin 36-inch culverts on Potter Creek at Fifty Six Road, approximately one mile upstream of Campfire Girls Dam

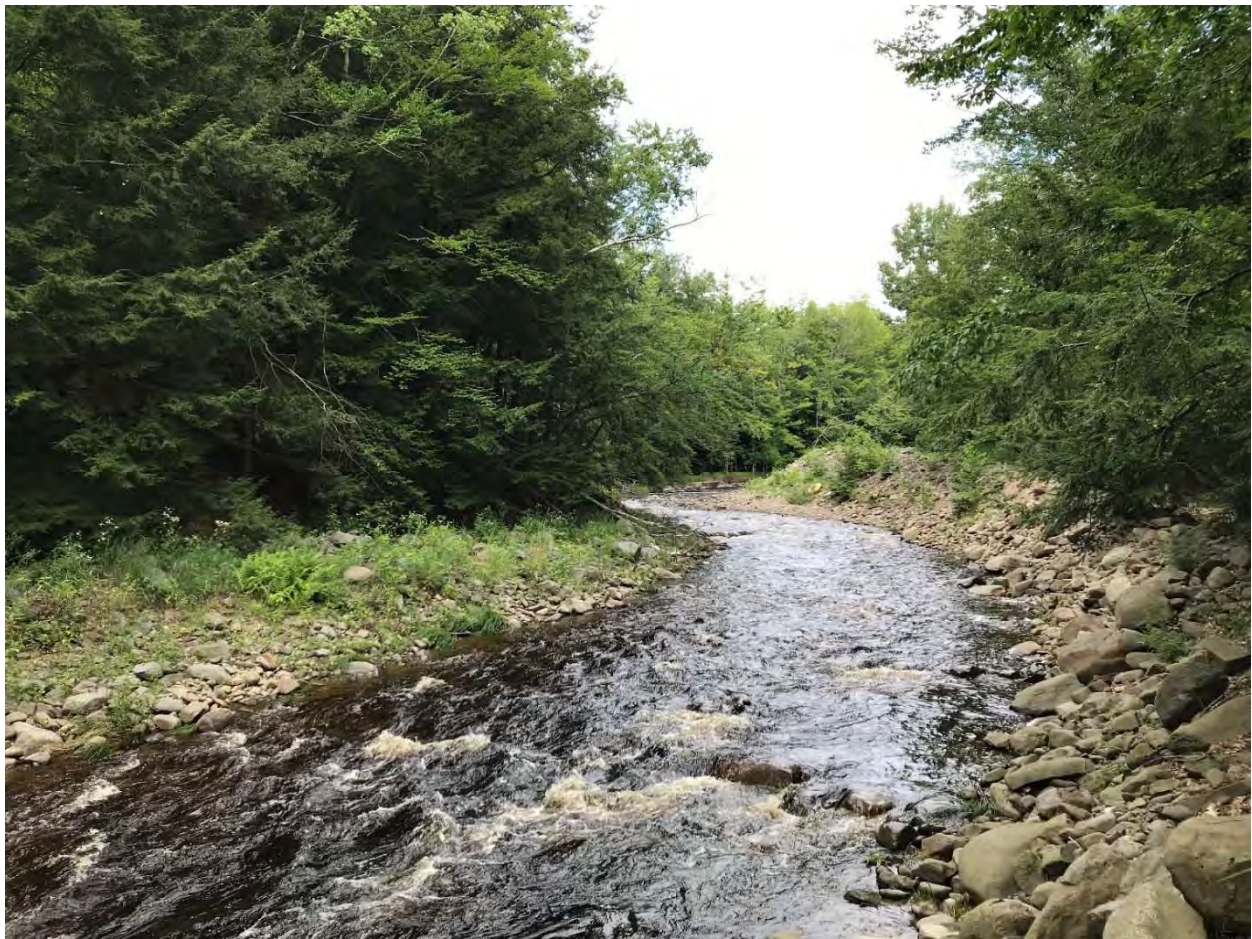
Plank Road runs through the narrow Poesten Kill valley along the face of the Rensselaer Plateau escarpment east from the hamlet of Poestenkill upstream past Barberville Falls to the headwaters of the watershed. Residences are located along the road where the valley is locally wide enough for limited property development; these areas correspond with local reductions in channel gradient. Multiple bridge crossings and the close proximity of the road and homes to the stream channel mean that Plank Road, similar to Route 2 along the Quacken Kill, is particularly vulnerable to the effects of extreme flood events. During Tropical Storm Irene, abundant coarse sediment sized from gravel to boulders was deposited in the channel, Plank Road was washed out, and private residences were damaged. The stream was subsequently dredged and material piled onto the top of the left bank to form a berm (Figure 17).

Figure 17. Looking upstream at the Poesten Kill as it flows along Plank Road upstream of Barberville Falls and the Blue Factory Road bridge. Bed material dredged from the channel has been piled up at the top of the bank on river left (right side of photo).

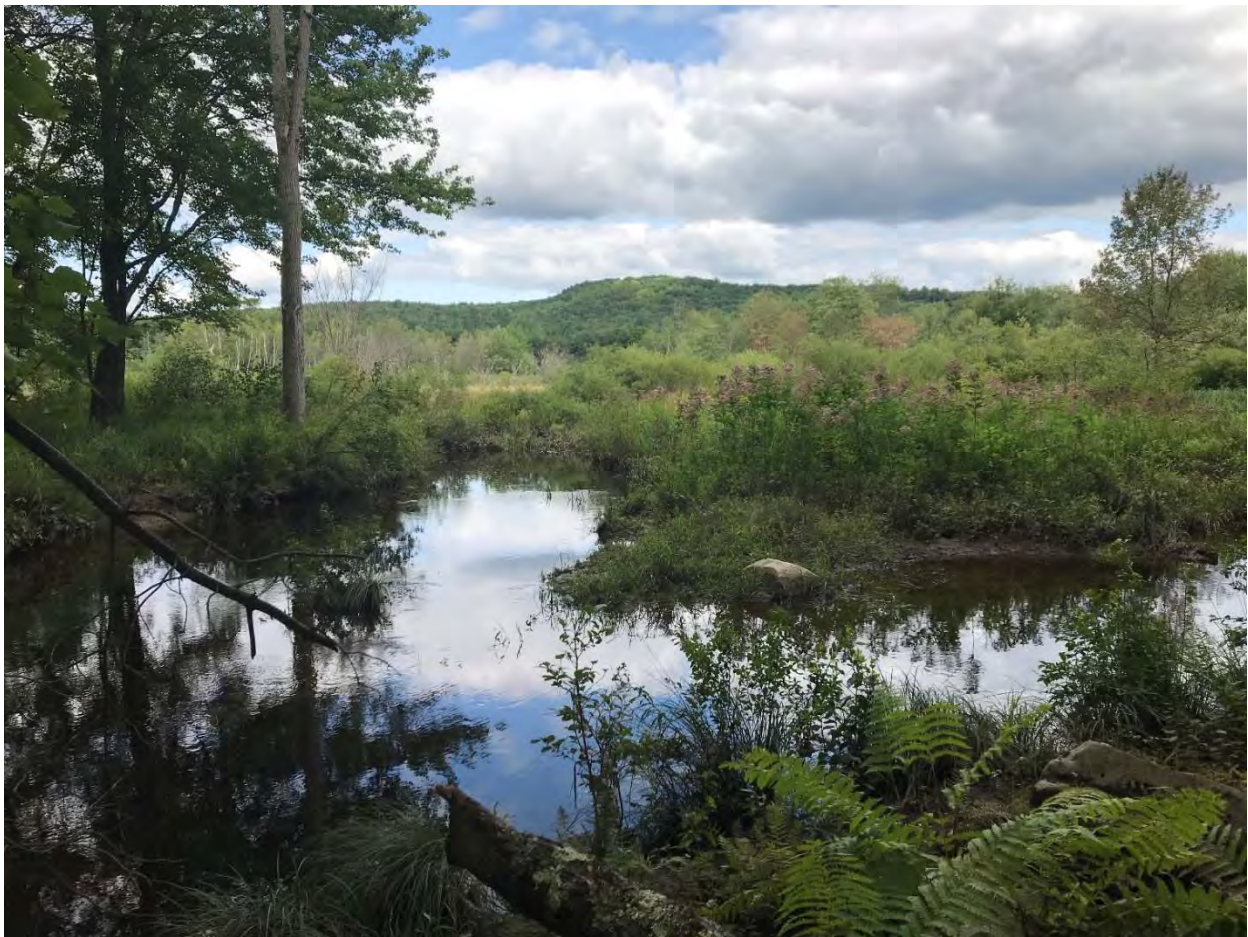
Channel flow resumes at the outlet of the wetland (Figure 19), approximately 350 feet upstream of the Columbia Hill Road culvert. The channel here is approximately 20 feet wide with a floodplain corresponding to bankfull conditions that narrows toward the culvert. The channel bed is composed of cobbles and gravel, and an existing riffle appears to provide the grade control for outflow from the wetland. Floodplain vegetation includes a combination of mature trees and herbaceous species, and evidence of recent activity suggests that the understory is actively managed and cleared. Hence, roughness elements such as large wood and boulders are scarce both in the channel and on the floodplain, with the wetland draining relatively unimpeded. Rensselaer County replaced the culvert under Columbia Hill Road with a large bottomless arch following washout of the road during Tropical Storm Irene.

Figure 19. Downstream end of Bonesteel Creek wetland located upstream of Columbia Hill Road

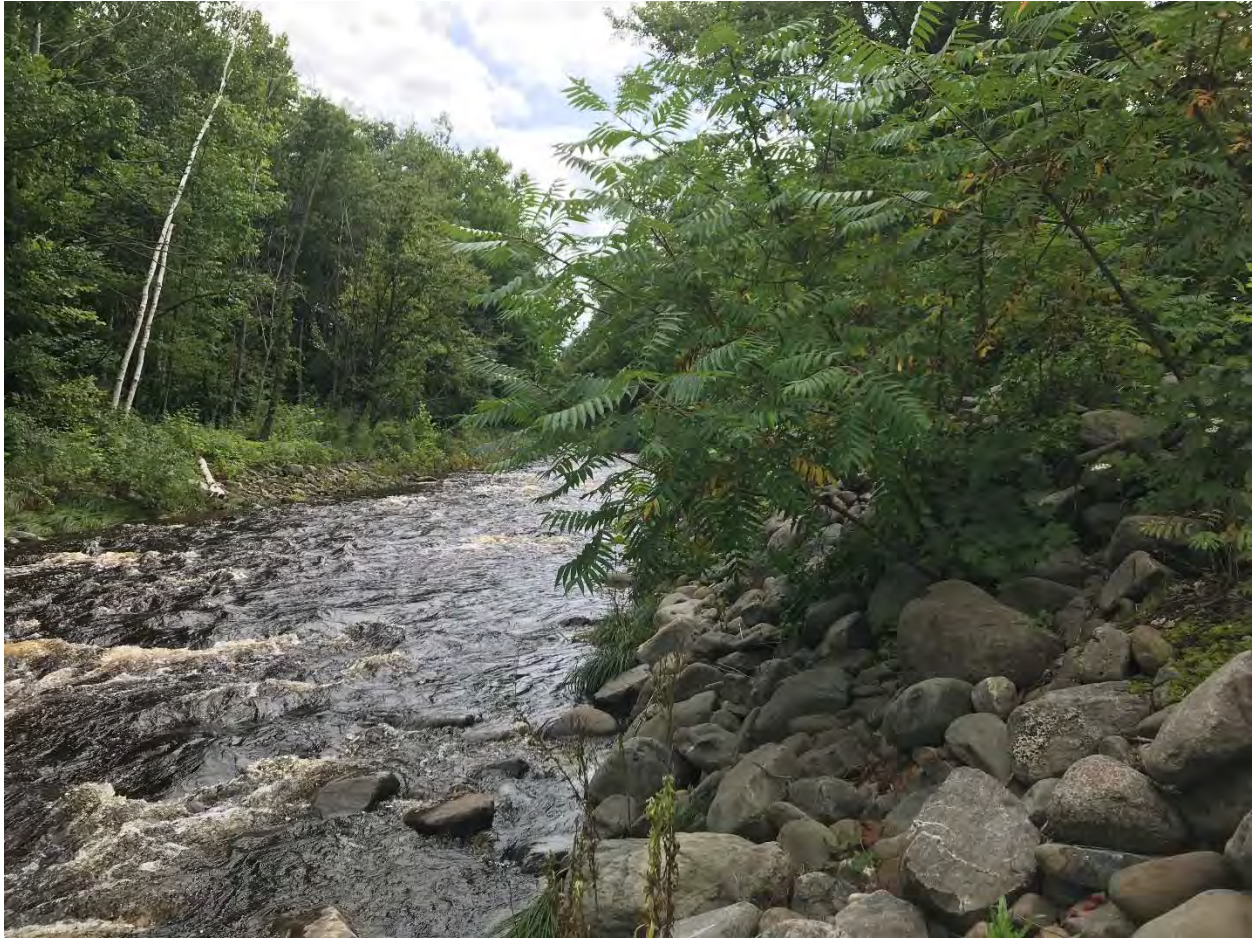
Gradient declines through this reach from approximately 0.01 ft/ft at the Route 351 bridge and flattening out at approximately 0.005 ft/ft at the fire station. In the channel near the station, bankfull width and depth were measured to be approximately 50 feet and 3.6 feet, respectively. The channel is oversized, and bankfull depth was estimated based on the elevation of a top of small floodplain bench on river right and indicators such as the top elevation of persistent granular erosion and bottom elevation of perennial vegetation growth. The top of the berm on river left sits approximately 2 to 3 feet higher than estimated bankfull and 1 to 2 feet above floodplain level (Figure 21). The bed is composed of mostly gravel and cobbles, with a median grain size of approximately 2 inches. The combination of lower gradient and oversized dimensions has made this stretch of the channel particularly prone to deposition. Dredging has also resulted in low complexity in flow and habitat; some alternating bars are present, but the reach is generally devoid of other features such as deep pools, overhanging banks, and large wood that would serve as habitat for fish and other aquatic species.

Figure 21. Looking upstream along the Poesten Kill channel at the Poestenkill Fire Station. Dredging and construction of a berm from dredged gravel has disconnected the channel from its floodplain on river left (right side of photo). A lower floodplain bench is visible on river right (left side of photo) adjacent to farm fields.
