## Appendix 6: Storm Preparation and Watershed Restoration Recommendations

## Recommendations for Stream & Flood Management in Dutchess County

Compiled by the  
Dutchess Area Environmental Science Advisory Network  
September 2008

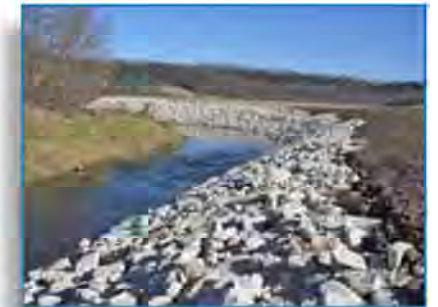
- If space allows, slope eroding banks to a stable slope, such as 3:1 (units of width to units of elevation) or flatter. Slope protection or erosion-control methods may be required. Slopes of as much as 2:1 may be considered when using rocks or other stable materials.
- To prevent future erosion on a river bend, incorporate rock vanes to deflect current away from the bank.

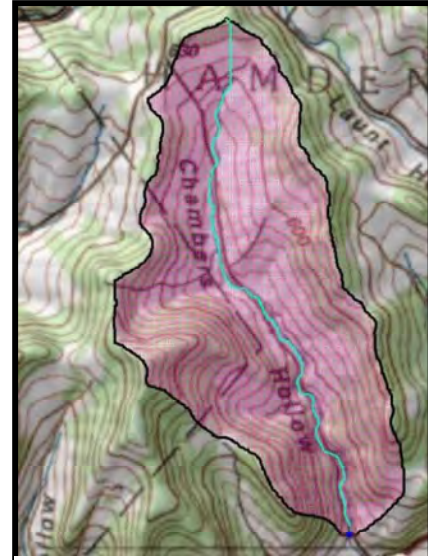
**Figure 2.2** Drainage area map from USGS StreamStat

Drainage area or watershed size is part of the physical characteristics of the watershed. The size of the watershed is defined by the amount of land area that has the potential to drain stormwater runoff into the stream network. The shape of the watershed also plays a key role in the stream network; if two watersheds have the same size but different shapes, they will have different peak discharges and times of concentration resulting from the same storm event. Travel time for runoff to move through the stream network varies with watershed topography. A steep watershed typically exhibits a higher peak discharge than a flatter watershed. Climate, geology, topography, vegetation, etc. affect timing and amount of stream flow, referred to as the stream's hydrologic regime. **Figure 2.2** is a drainage area map for Chambers Hollow in the Town of Hamden, produced using StreamStats; a water resource program developed by the United States Geological Survey (USGS).

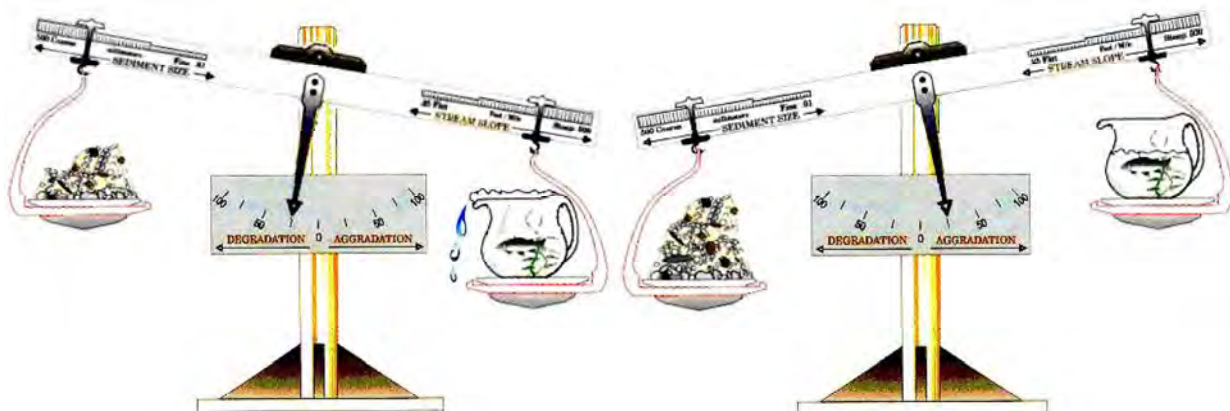
**Figure 2.5a** If the supply of sediment decreases or the supply of water increases, the stream will begin to erode the stream bed or degrade. (After Rosgen, 1996)

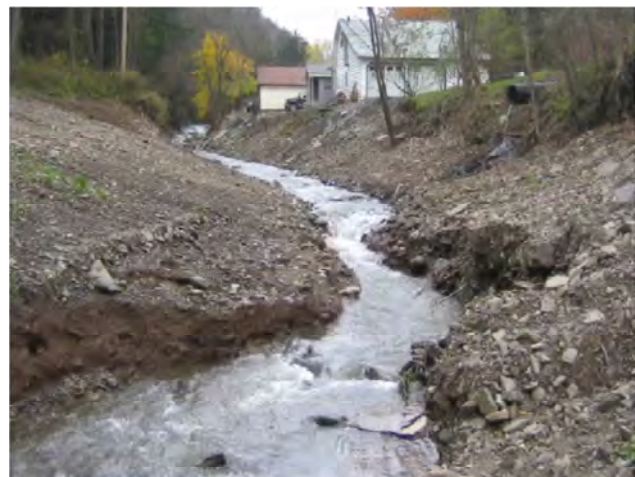
**Figure 2.16 Headcut on Third Brook in Walton, NY**

All of this leads to serious instabilities in the reach. Unfortunately, that is not all that can happen. The headcut, if left unchecked, will proceed upstream and destabilize more of the stream. The erosion and gravel deposition will proceed downstream and destabilize the downstream reach. If the upstream and downstream reaches are stable then this chain reaction will result in an unstable reach. If the unstable reach was further compromised with improper stream management such as dredging, the impact will further destabilized the reach resulting in steeper bank erosion. This will be greater nuisance to the municipality or landowner which may be a danger to public safety and may cost additional funding to correct the situation. The example shown in **Figure 2.16**, shows a headcut moving upstream on Third Brook in Walton, NY after post-flood work using traditional deeper -wider u-shape (parabolic) stream channel was completed to repair damages from the 2006 storm event. This headcut eroded the streambed down 6 feet which has compromised existing high eroding banks within the reach. The municipality has received funding to repair some areas of the reach and is currently in the process of developing a stream management plan to address several mass slope failures within the reach.

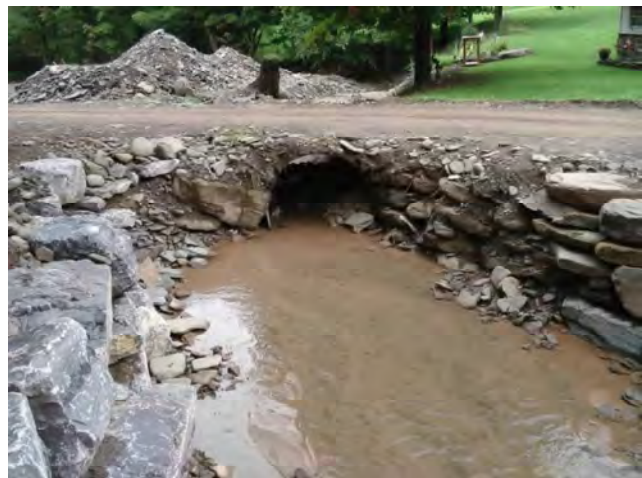
**Figure 2.17 Culvert Conveying on Holliday Brook  
Colchester, NY**

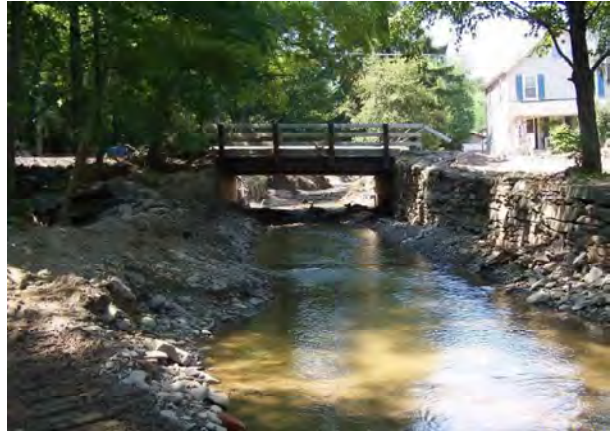
**Figure 2.18 Bridge results in elimination of Floodplain**

may affect the designed flow capacity of the channel beneath the bridge. In many instances, the sediment must be excavated to maintain the design capacity. Bridges built narrower than the stream's natural dimensions will exhibit a depositional wedge upstream of the structure. This may lead to water to become backed up behind the bridge, resulting in local flooding upstream. Bridge approaches are usually built across floodplains in order to have a gradual transition onto the bridge. These become a floodplain block (see Figure 2.18).

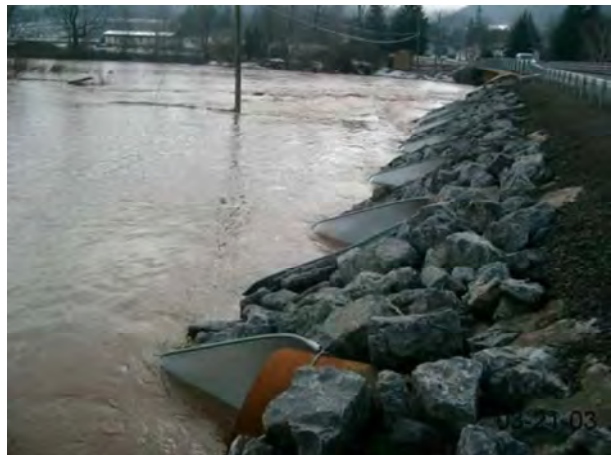
**Figure 2.19 Floodplain culverts along Delaware County Route 2 Hamden, NY**

Bridges can force water and debris that would normally be on the floodplain through a narrow opening, concentrating energy that can cause problems downstream of the bridge, such as streambank and stream bed erosion or debris plugging bridge openings. Allowing the water to convey thru floodplain culverts placed in bridge approaches will allow water to access the floodplain and reduce the risk of water backing up behind the bridge debris jams under bridges (Figure 2.19).

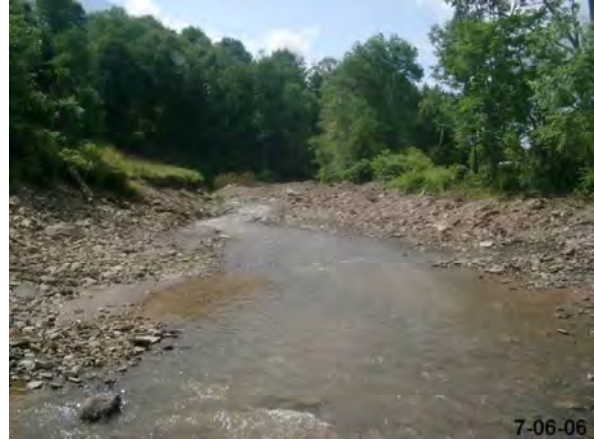
**Figure 3.1** Section of stream that has been flooded.

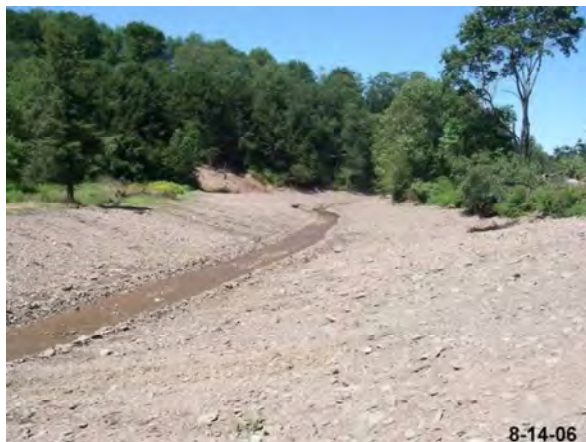
**Figure 3.2** The classic parabolic stream channel shape.

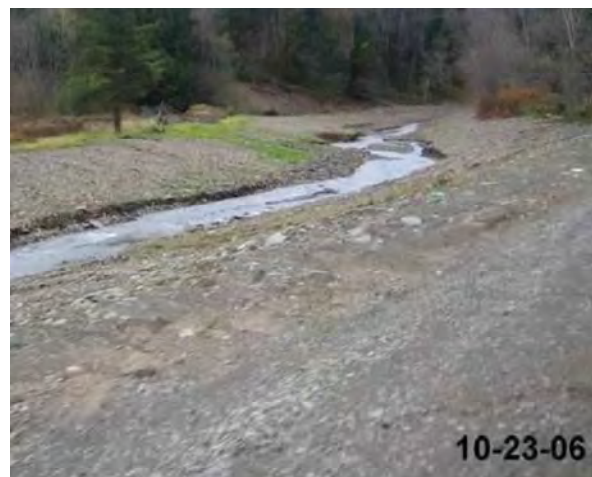
**Figure 3.3** Two months of stream channel evolution.

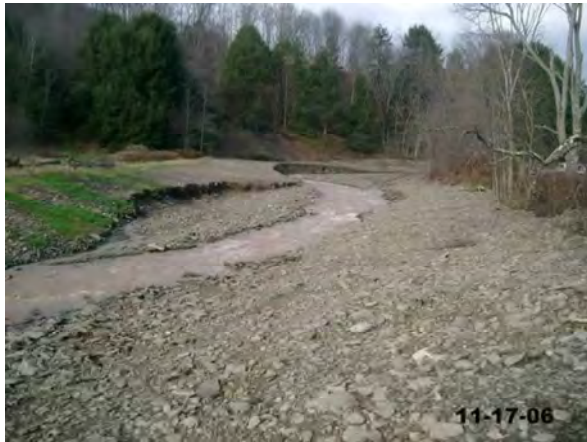
**Figure 3.4** shows the stream channel three months after construction. The stream has continued to adjust, further eroding its streambanks and creating a floodplain. The original floodplain is so high that it is now a terrace.

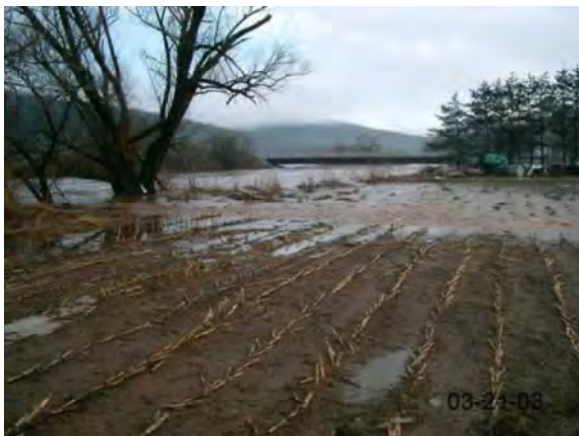
**Figure 3.11** Functioning Floodplain

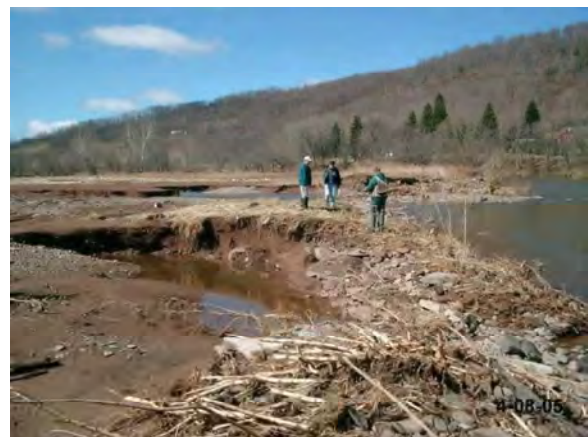
**Figure 3.12** Berm that was breached in 2005 storm event

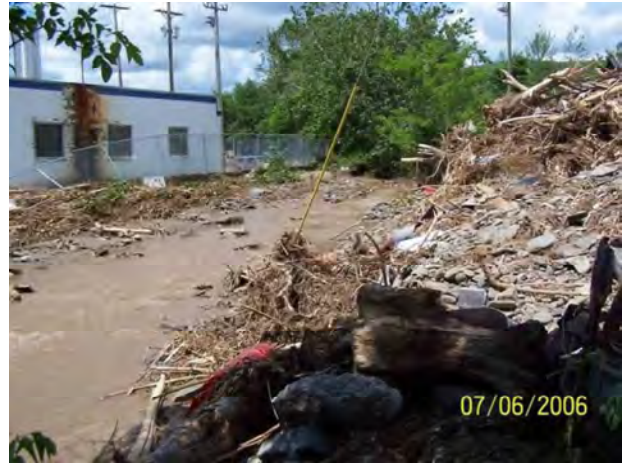
**Figure 3.13 Shows stream channel after flood event.**

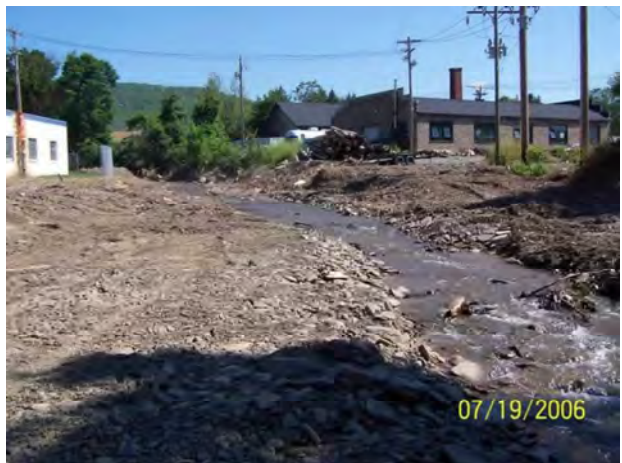
**Figure 3.14 Stream channel after Post Flood Intervention.**

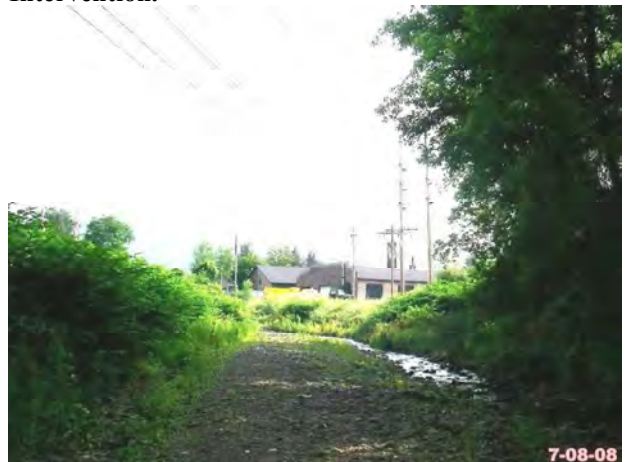
**Figure 3.15 Two years after Post Flood Intervention.**

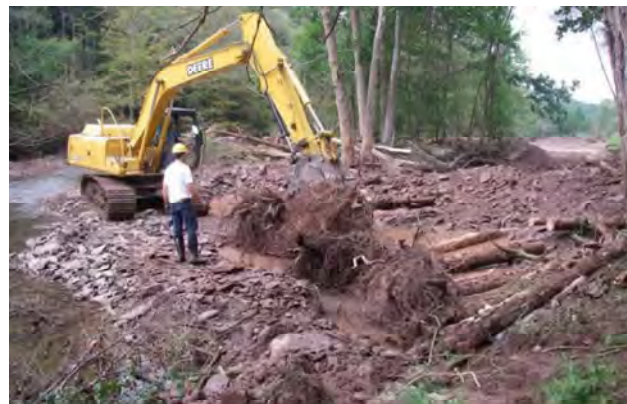
**Figure 3.16** Root wads were placed in two layers with large boulders or logs to hold them in place

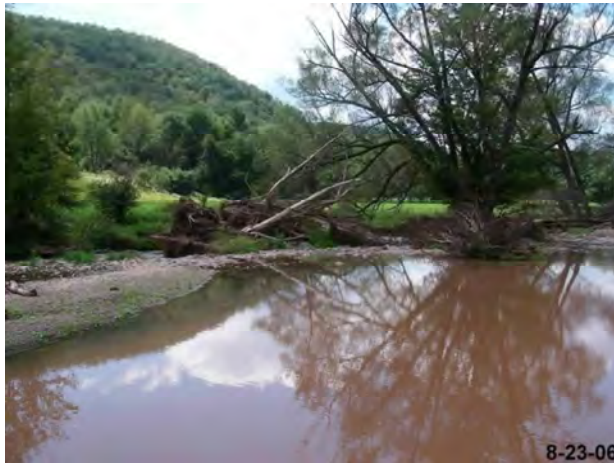
**Figure 3.17** Stream impacted by the 2006 Flood.

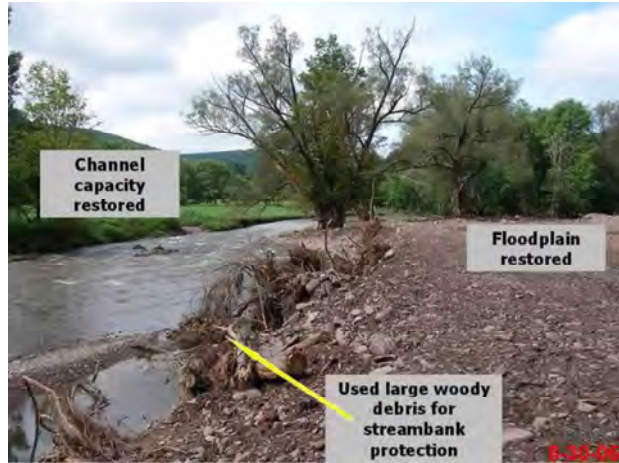
**Figure 3.18** Stream construction using Regional Bank full Hydraulic Geometry values, typical cross-section and root wad.

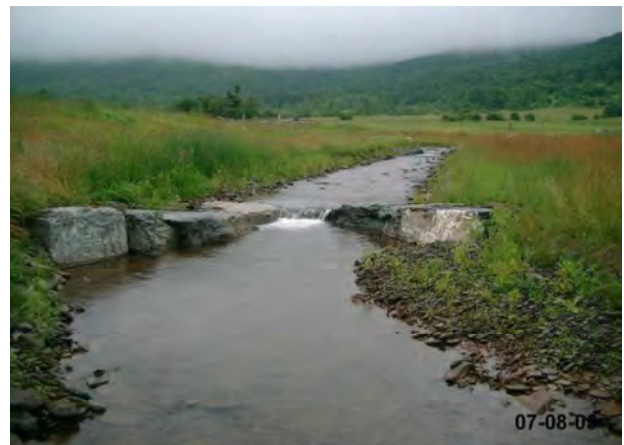
**Figure 3.19** Rock Cross-Vane

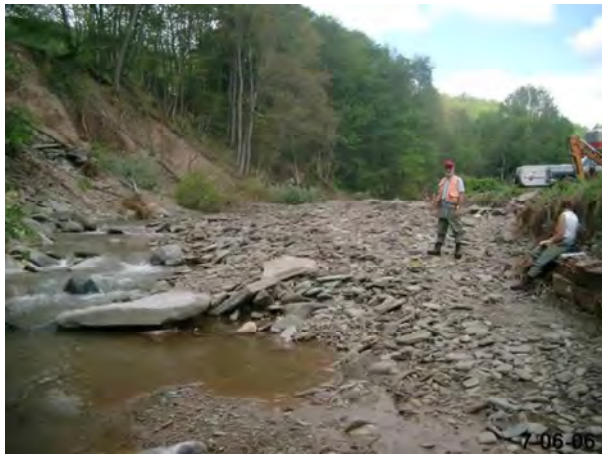
**Figure 3.20** shows imbrication after the 2006 flood.

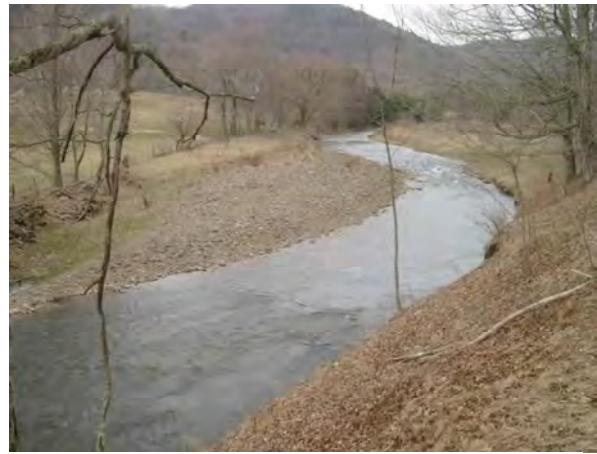
**Figure 3.22** shows downcutting after dredging.

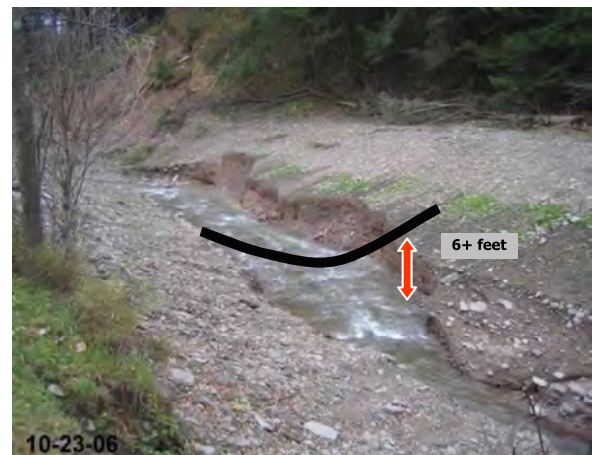
**Figure 3.21** Looking upstream at a point bar in the Tremper Kill Sub-basin
